WASTEWATER TRANSPORT SYSTEM
EVALUATION
HUNT ST. AND ROSE ST. PUMP STATION
SERVICE AREAS – STUDY 3

for the
CITY OF BATH, MAINE

APRIL 2017

**Wright-Pierce
99 Main St.
Topsham, ME 04086**

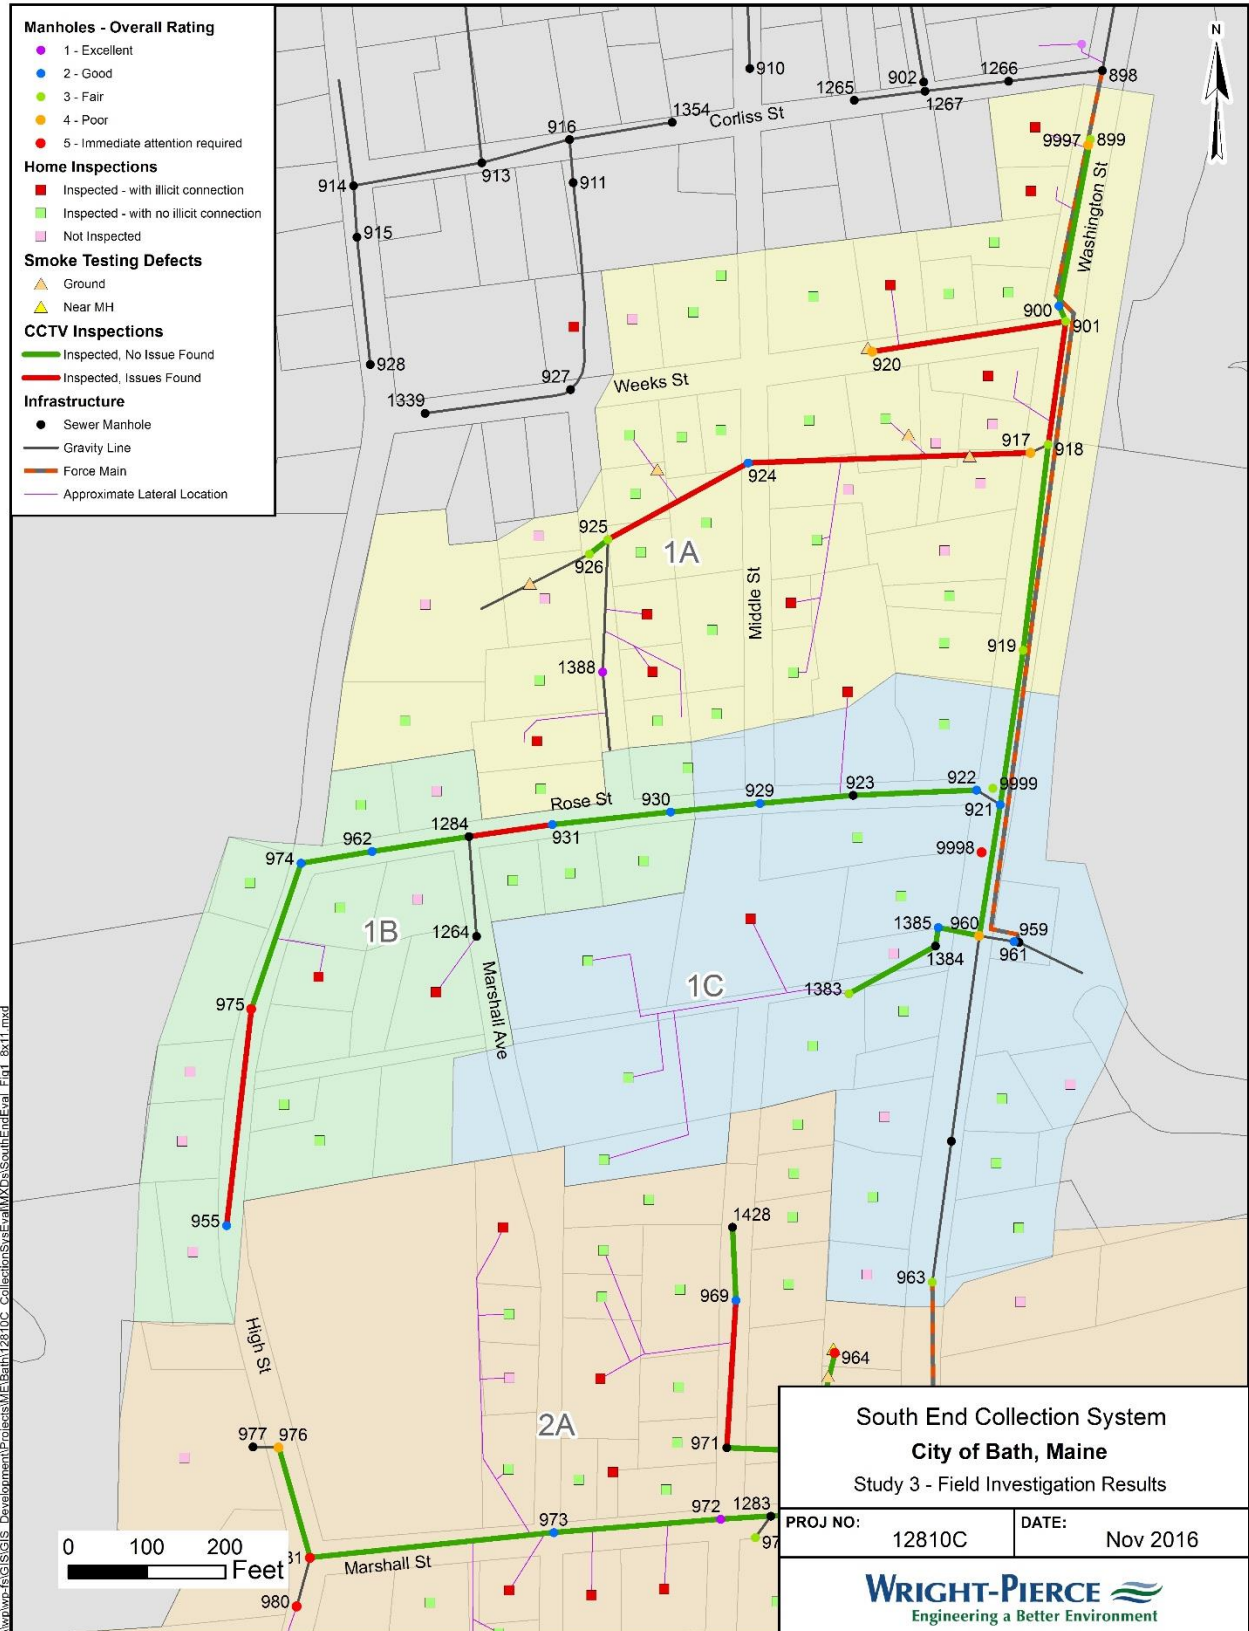
**FIGURE 2-1
SUB-AREAS 1A, 1B, AND 1C FIELD INVESTIGATION RESULTS**

As part of Study 3, all 12 sewer manholes in Sub-Area 1A were inspected. Out of the 12 manholes inspected, nine ranged from fair to excellent condition, with three being in poor condition (i.e. cracks in various parts of the manhole, but no defects that require immediate reparative action due to infiltration). No manholes in this sub-area require immediate attention.

Four of these sections showed significant signs of possible infiltration in the pipe: the sewer section between SMH-901 and SMH-918, between SMH-920 and 901, between SMH-924 and SMH-917, and between SMH-925 and SMH-924. The TV inspection data between SMH-901 and SMH-918 shows that the sewer main is in poor condition and shows signs of infiltration. The video showed many cases of cracks (both longitudinal and latitudinal), broken pipe, and a tap break-in protruding. The section between SMH-925 and SMH-924 showed multiple longitudinal cracks, fractures, and cases of fine root protrusion. Though there were no actual infiltration stains in these sections of piping, breaks and cracks in the pipe could allow infiltration.

The TV inspection data between SMH-920 and SMH-901 showed one infiltration dripper and multiple cases of fine root protrusion through joints and circumferential fractures. The infiltration dripper is a clear indicator of infiltration in the pipe, and other signs present indicate potential infiltration in this section. The video between SMH-924 and SMH-917 showed that the sewer main is in very poor condition and shows signs of infiltration. The video showed numerous issues which could be causing infiltration, such as root penetration, cracks, and joint offsets of the piping.

As part of Study 3, six out of the eight sewer manholes in Sub-Area 1B were inspected. Five of these manholes are in good to excellent condition, and one (SMH-975) needs immediate attention. During the inspection, SMH-975 had groundwater entering the manhole from joints in the barrel dripping down the walls, as well as corrosion of the rim. In addition, a constant steady flow of clean groundwater was coming in above the invert of the outlet pipe. This significant infiltration above the outlet pipe invert suggests that the pipe is broken. It should be noted that a rain event occurred the day before the inspection, which likely contributed to the magnitude of groundwater entering the manhole.

The TV inspection data between SMH-955 and SMH-975 showed that the sewer main is in poor condition and showed signs of infiltration. The video showed root protrusion into a joint in the pipe, as well a large crack with an infiltration stain. There was also a sizable hole in the pipe, through which soil is visible. The survey, which started at SMH-975, was abandoned approximately 100 feet before reaching SMH-955 due to the inability to navigate the camera further.

The TV inspection data between SMH-1284 and SMH-931 showed four cases of broken pipe where soil is visible. These cases can be seen 34 feet, 48 feet, 103 feet, and 109 feet downstream of SMH-1284. To view the complete reports for the pertinent video inspected sewer lines, see Appendix B.

As part of Study 3, 10 of the 14 sewer manholes in Sub-Area 1C were inspected. Eight of these manholes are in fair to good condition, one manhole is in poor condition (SMH-960), and one manhole needs immediate attention (SMH-9998 – This manhole was identified in the field and arbitrarily numbered since it was not present in the City’s GIS Database). SMH-960’s invert is corroded and the walls are cracked, which may lead to infiltration, although none was observed at the time of inspection. Bricks are also missing in the table and the risers. A previously connected old storm line has been plugged with bricks, however, there is still some evidence of infiltration from this line. SMH-9998 had not been identified in the City’s GIS database, and it was unclear

The CCTV data did not show any significant signs of I/I in this sub-area, and indicated that the sewer pipes are in good condition. It should be noted that the condition of the shared lateral along the old paper road is unknown and should be investigated further. A cleanout is located upstream of the four tie-in points and may allow for insertion of a camera to collect CCTV data.

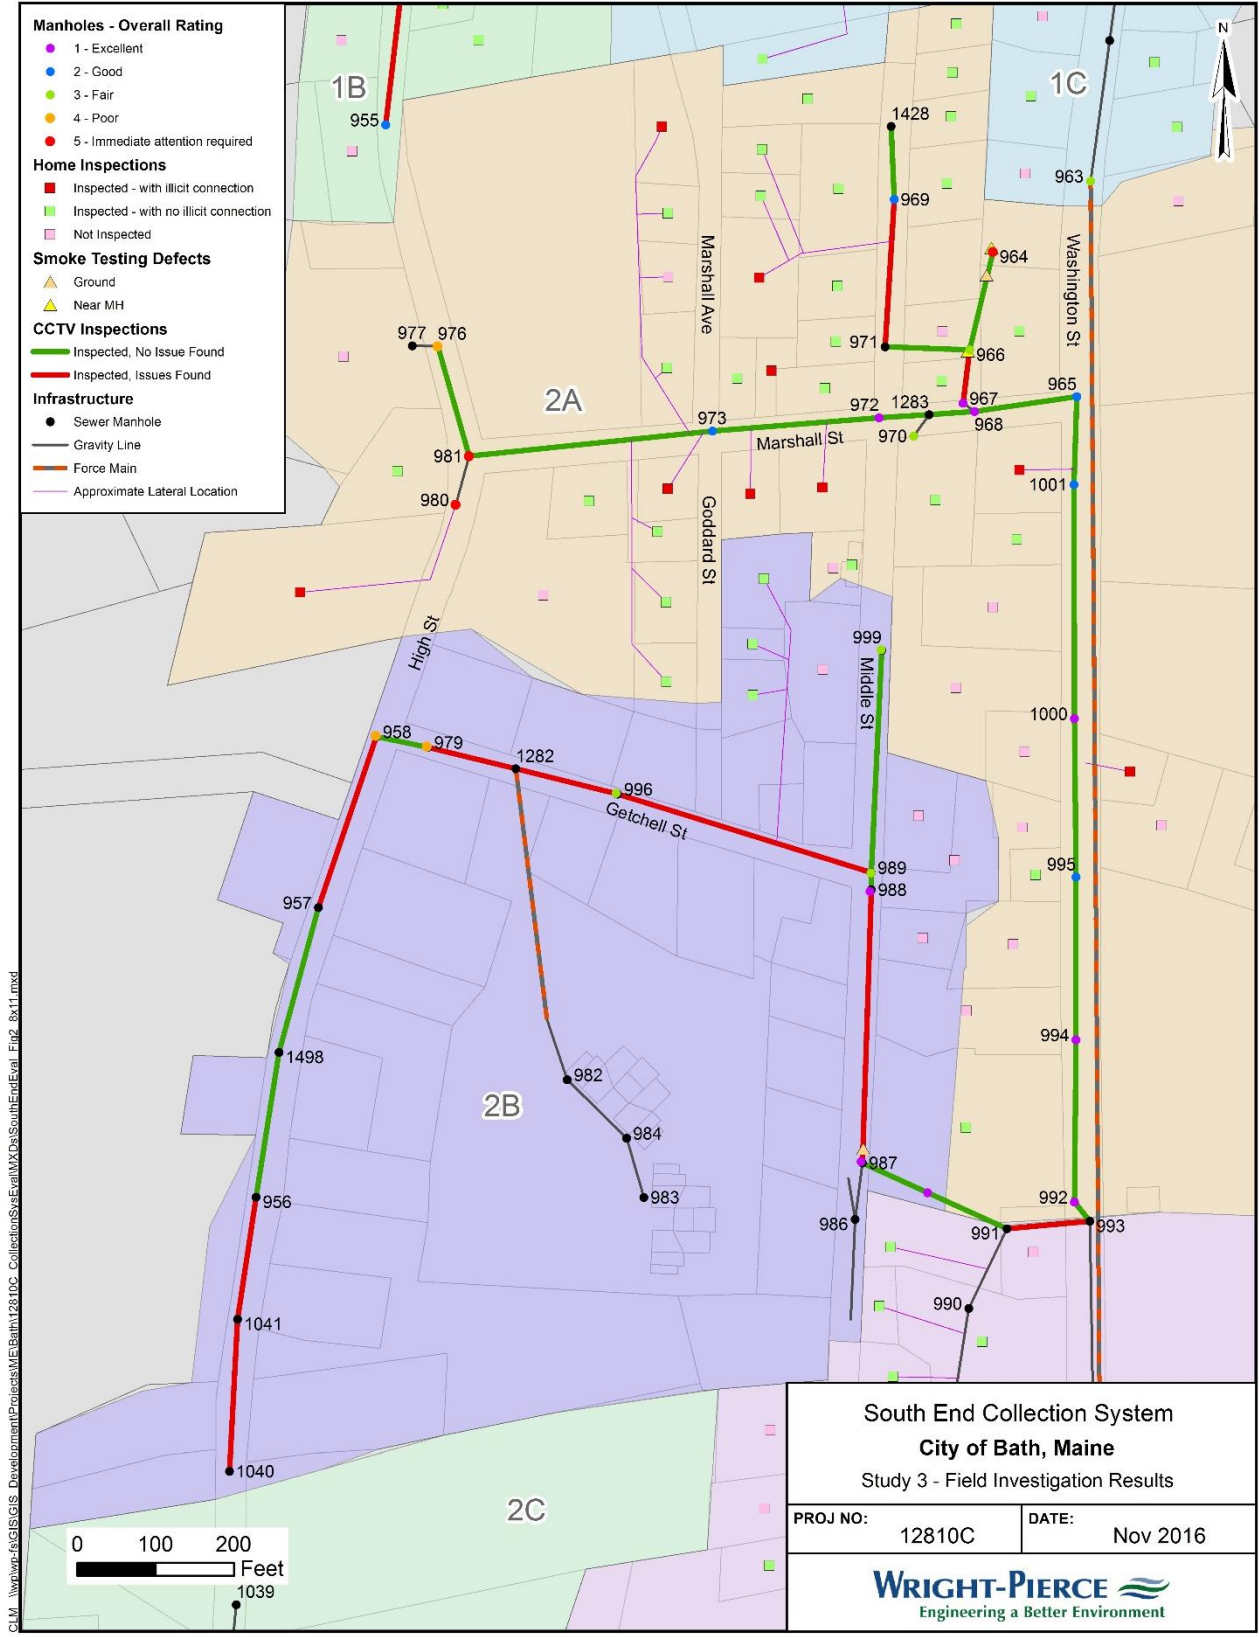
**FIGURE 2-2
SUB-AREAS 2A AND 2B FIELD INVESTIGATION RESULTS**

Flow monitoring performed in Study 2 found peaking factors (ratio of wet weather flows to average flows) to be very high in this sub-area, ranging from 74 to 118 for the three wet weather events analyzed. These peaking factors and the immediate increase in flows during the wet weather events indicate direct inflow to the collection system. The presence of infiltration was also apparent, as it took 2 to 5 days for flows to return to baseline flow rates. Field investigations identified defects along the cross-country sewer line between Middle Street and Washington Street, north of Marshall Street. Continuous clean flow from this line was observed in a manhole on Marshall Street during instantaneous flow metering. A large area of the ground along this cross-country line smoked during testing, and smoke was seen coming from the ground around two manholes. Nearby ground was saturated, so leaks in the cross-country line likely allow a significant amount of infiltration.

As part of Study 3, 17 of the 21 sewer manholes in Sub-Area 2A were inspected. 13 of these manholes are in fair to excellent condition, one manhole is in poor condition (SMH-976), and three manholes need immediate attention (SMH-964, SMH-980, and SMH-981). SMH-976's invert and steps are corroded and the walls are cracked. The outlet pipe is also cracked on top and the top of the chimney is corroding away. Wall sections are shifted and cracked, and may be contributing to some infiltration.

SMH-964 showed signs of both inflow and infiltration during the inspection. There is an open channel into the manhole and two holes into the manhole which allow for drainage from the surrounding low-lying area to enter the structure. In addition, the walls and risers of the manhole are broken and the rim is corroded (pitted).

SMH-980 and SMH-981 showed signs of infiltration. In SMH-980, there was steady, clean flow coming into the manhole through a crack in the wall where the grout had eroded away. In addition, the riser and walls of this manhole are cracked. In SMH-981, there was steady infiltration coming into the manhole from two different cracks in the wall. There were also numerous bricks in the inverts (possibly from when the rim was reset), cracking in the riser, and corrosion on the table.

Two of these sections showed significant signs of possible infiltration in the pipe: the sewer section between SMH-966 and SMH-967 and between SMH-969 and SMH-971. The TV inspection video between SMH-966 and 967 significant root protrusion throughout the sewer section; the CCTV inspection was abandoned due to the extent of the roots present in the piping. The video for the section between SMH-969 and 971 showed one case of broken pipe with soil visibility as well as multiple (fine and medium) cases of root protrusion at joints. To view the complete reports for this inspection video, see Appendix B.

Seven of the 15 sewer manholes in Sub-Area 2B were inspected. Five of these manholes are in fair to excellent condition and two manholes are in poor condition (SMH-958 and SMH-979). SMH-958 has cracking in the riser and the invert is full of debris (cement is partially blocking the line). SMH-979 has a broken rim, riser, and wall, as well as a broken invert. While no infiltration was observed, it could occur in both manholes during wet weather conditions.

Six of the sewer sections listed above show signs of infiltration and wear in the sewer main. The sewer between SMH-957 and SMH-958 showed signs of infiltration (six separate infiltration stains and an infiltration drip) as well as points of settled deposits. The survey, which started at SMH-957, was abandoned approximately 125 feet before reaching SMH-958 due to the inability to navigate further. The sewers between SMH-988 and SMH-987 and between SMH-996 and SMH-989 also showed significant signs of infiltration. Though no infiltration drippers could be seen in the videos for these sections, the video between SMH-988 and SMH-987 showed two holes as well as multiple fractures, large joint offsets, and medium root protrusion through the joints. The video between SMH-996 and SMH-989 had one case of broken pipe through which the void was visible.

The remaining three sewer mains in the list above showed several cases of root protrusion into the sewer line. The inspection video between SMH-1040 and SMH-1041 showed multiple root issues, and a circumferential crack in the pipe present near SMH-1040. The inspection video between SMH-1041 and SMH-956 showed roots in joints, multiple fractures in the pipe at one section of root protrusion, and one circumferential crack in the pipe (visibly unrelated to root protrusion). The inspection video between SMH-1498 and SMH-957 showed significant root protrusion; because of these roots, the equipment could not navigate further toward SMH-1498, resulting in survey abandonment. To view the complete reports for these inspection videos, see Appendix B.

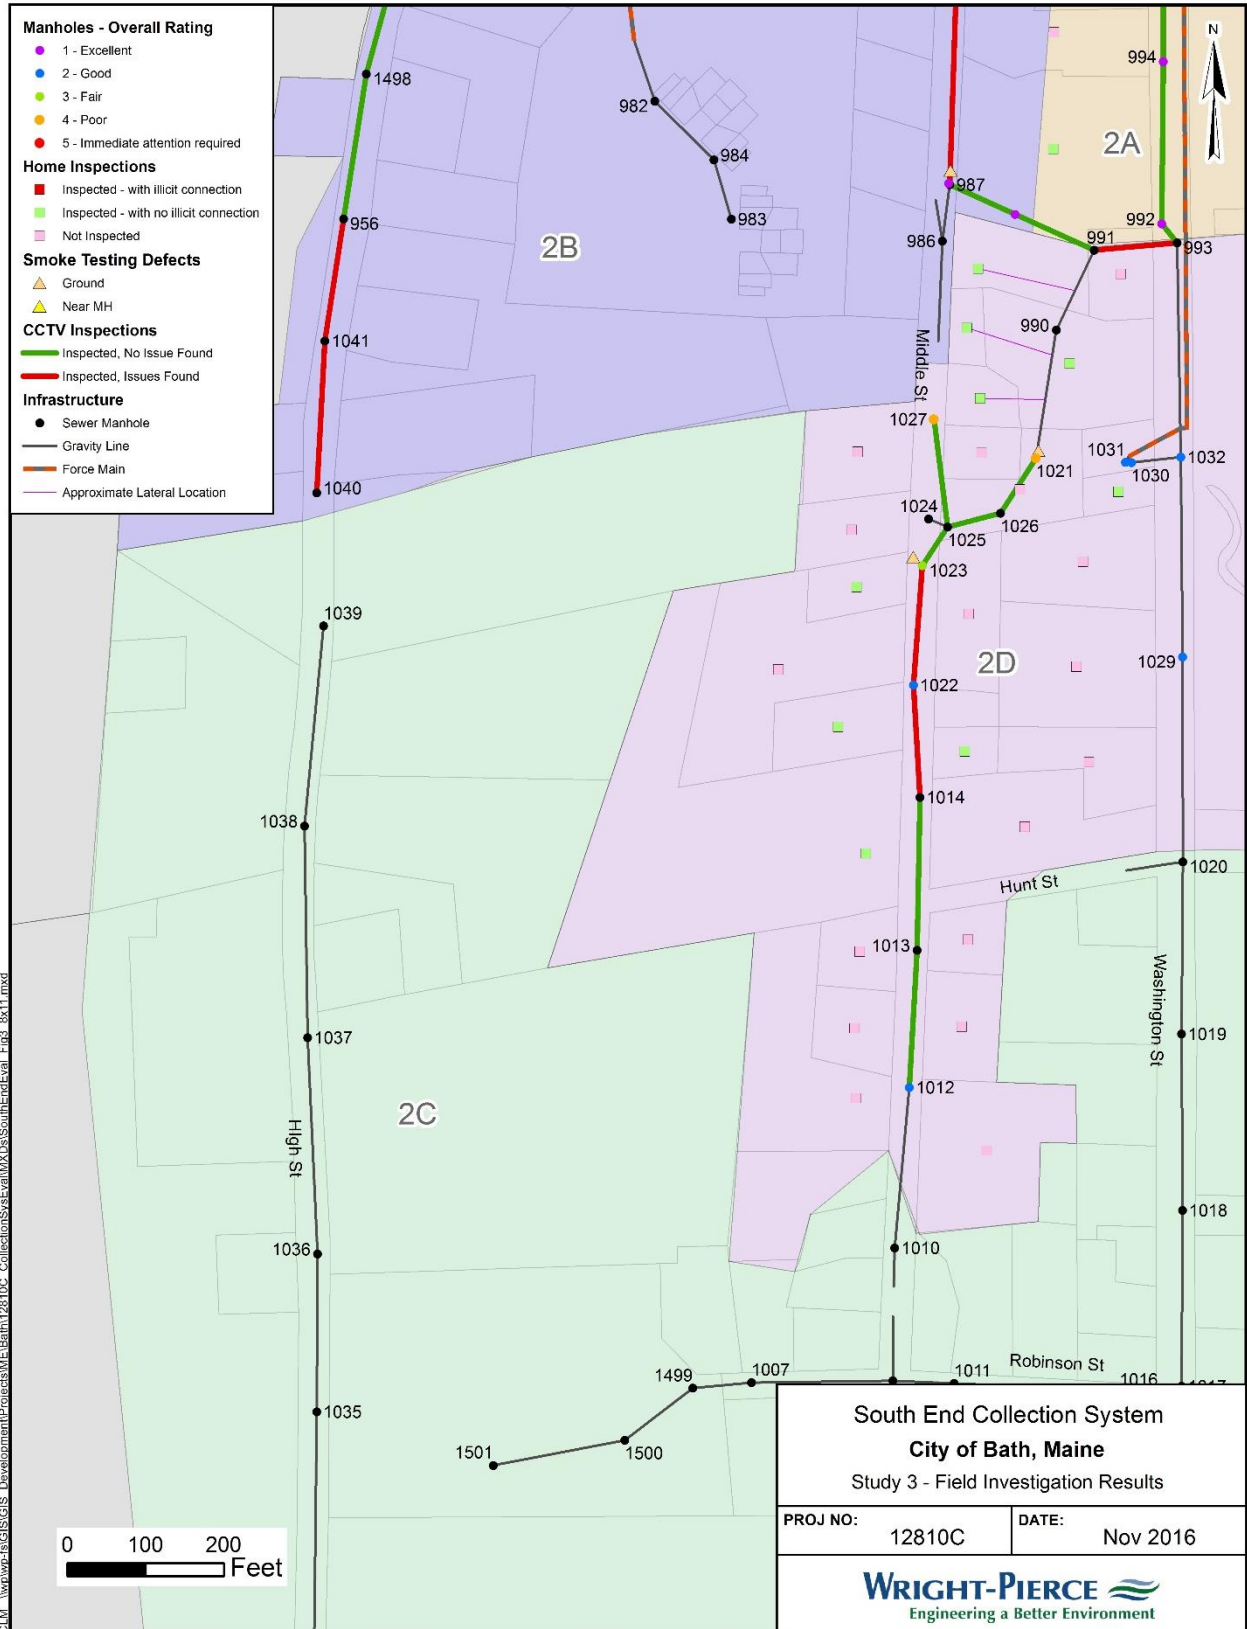
**FIGURE 2-3
SUB-AREAS 2C AND 2D FIELD INVESTIGATION RESULTS**

As part of Study 3, nine of the 17 sewer manholes in Sub-Area 2D were inspected. Seven of these manholes are in fair to good condition and two manholes were in poor condition (SMH-1021 and SMH-1027). SMH-1021 has a cracked riser and walls, as well as missing steps. At the time of inspection, the manhole was surcharged and the condition of the table and invert could not be determined (manhole needs to be cleaned). SMH-1027 has a cracked riser and corroded rim, steps, and table. The walls are seeping and could be a potential source of infiltration. At the time of inspection, there was standing water in the manhole and the inverts had excessive debris blocking flow.

Three of these sewers showed signs of possible infiltration: the sewers between SMH-991 and SMH-993, between SMH-1014 and SMH-1022, and between SMH-1022 and SMH-1023. Infiltration was seen in two of these sewers: the video between SMH-991 and SMH-993 showed one infiltration stain and the video between SMH-1014 and SMH-1022 showed two cases of significant root protrusion and one infiltration dripper. The video between SMH-1012 and SMH-1014 showed multiple root protrusions. To view the complete reports for these inspection videos, see Appendix B.
