MORSE HIGH SCHOOL CONCEPT DEVELOPMENT REPORT – DRAFT FOR REVIEW

DECEMBER 1, 2021

Morse High School Concept Development

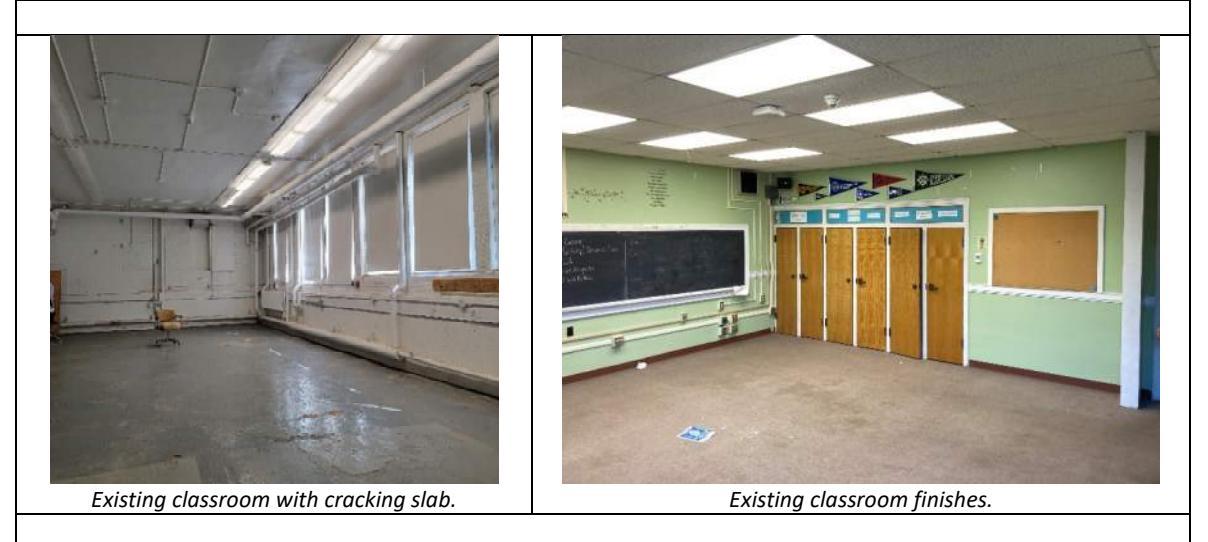
Conditions of the classroom interior finish materials are generally in good condition but have seen areas of decline. Some ground level floor slabs are uneven with numerous cracks. Window replacements occurred in 2014 as part of facility maintenance, and finishes were patched around the windows as part of this work. While most of the existing flooring has been replaced with VCT, future renovation and finishes replacement will require asbestos testing, particularly for flooring and flooring mastic.

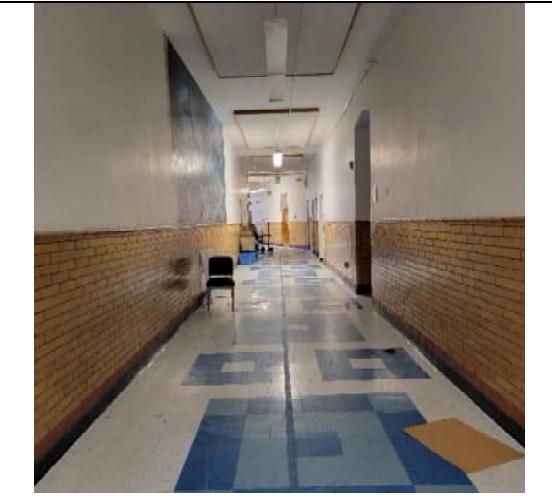
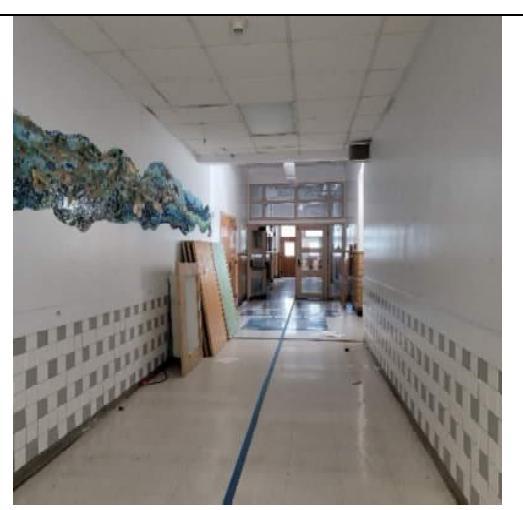
Existing corridor interior finish materials are generally in good condition. Many corridors have tile wainscoting with plaster above. The third floor has a ramp to gain access into the adjacent 1968 wing. It's believed the ramp is built up construction and can be removed to regain functional space when the 1968 wing is demolished. While most of the existing flooring has been replaced with VCT, future renovation and finishes replacement will require asbestos testing, particularly for flooring and flooring mastic.

Existing 1928 corridor conditions.

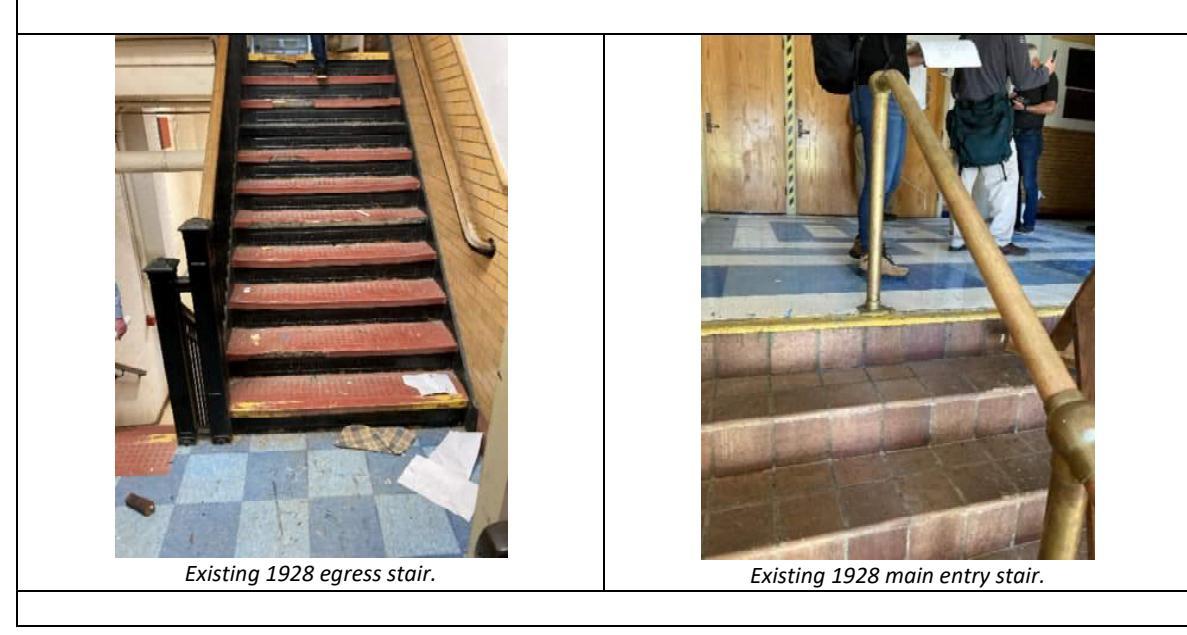
Existing stairs do not meet current codes or accessibility requirements, such as tread and riser dimensions, guardrails, handrails, and fire separation for egress stairs. Existing stairs are allowed under the existing building code regulations and would be considered compliant if in the opinion of the code official, they do not constitute a distinct hazard to life. New guardrails, handrails and fire separations are anticipated as being required with any significant building upgrades or change of use, if the stairs are to remain as part of the egress route. Elevators currently allow access to all levels except the 1928 building gymnasium level. With the proposed demolition of the 1941 and 1968 wings, a new elevator will need to be added to provide access. Future renovation and finishes replacement will require asbestos testing.

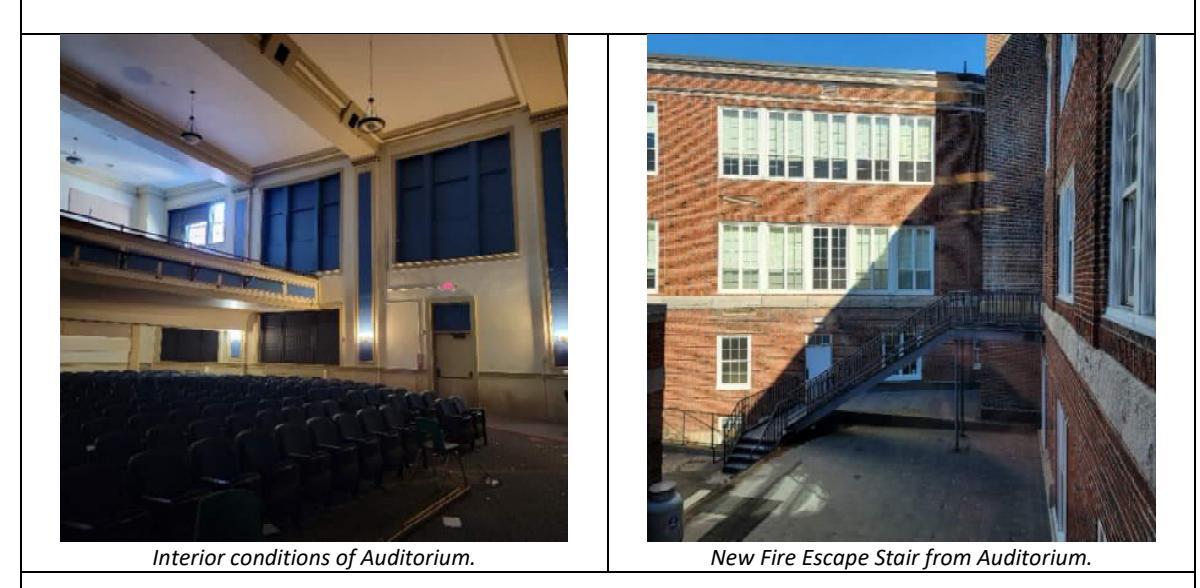
The existing auditorium is in decent condition. It has been recently renovated (past 10-15 years?) in comparison to the rest of the building. The fire escape stairs from the auditorium were replaced as part of the 2014 facilities maintenance renovations.

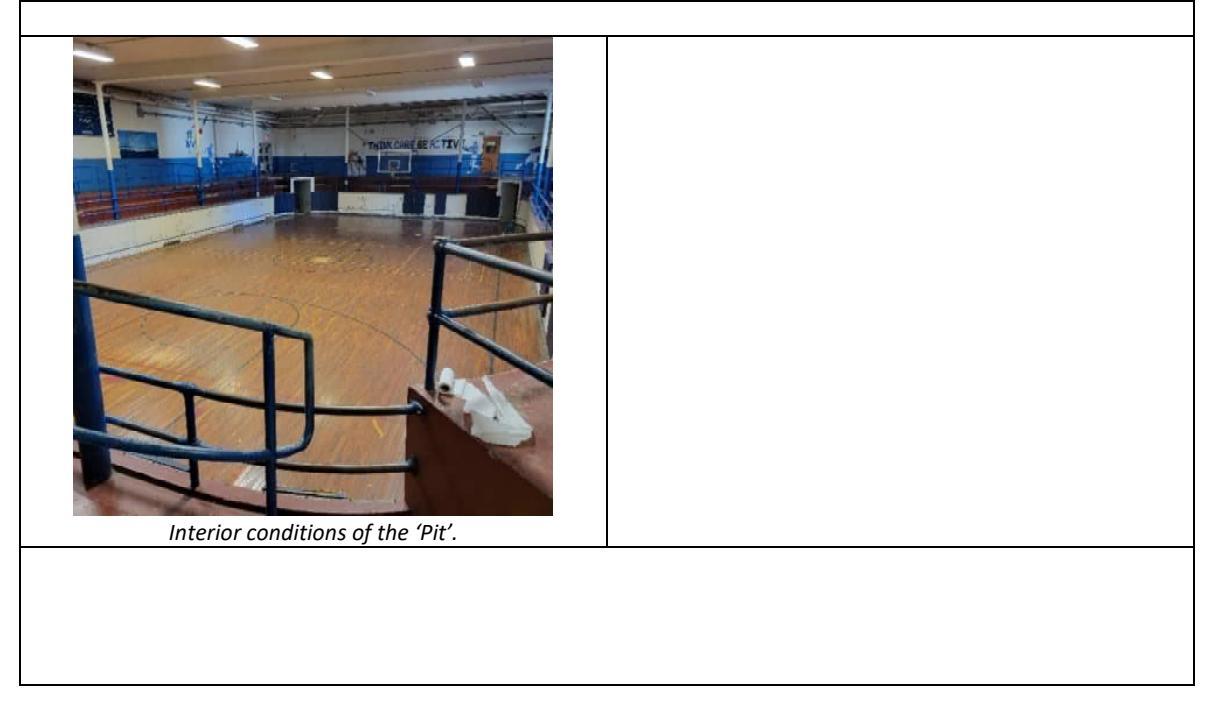
The existing gymnasium, known as 'the Pit', is located below grade in the center of the building. This basement level is only accessible by stair, or a mixture of elevator/stair/lifts through the additions and presents numerous issues for accessibility. The boiler room is also located off this level, with additional exterior access.

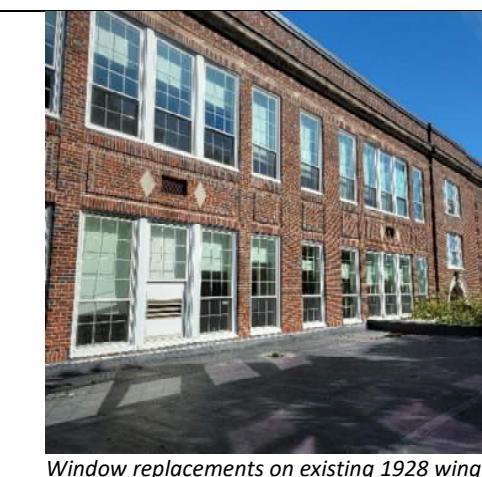
Windows in the existing 1928 building were replaced as part of facility maintenance in 2014, and minor interior patching was completed to address moisture issues seen at the interior finishes.

Window replacements on existing 1928 wing.

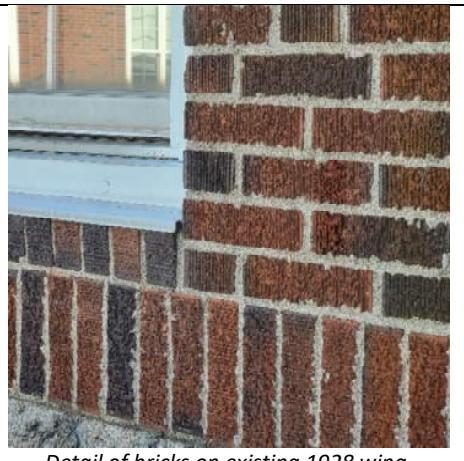
The existing façade is comprised of a steel structure with brick facades. The original 1928 building was constructed of a brick that was found to have a high level of porosity leading to moisture migration through the wall, and plaster deterioration and efflorescence on interior walls. To prevent continual migration of moisture through the walls, it was recommended that the building undergo sealing of the brickwork as part of a periodic maintenance program, with resealing occurring approximately every two years.

Detail of bricks on existing 1928 wing.
